SPECTRA LOGIC

Spectra[®] 10K Library Firmware History

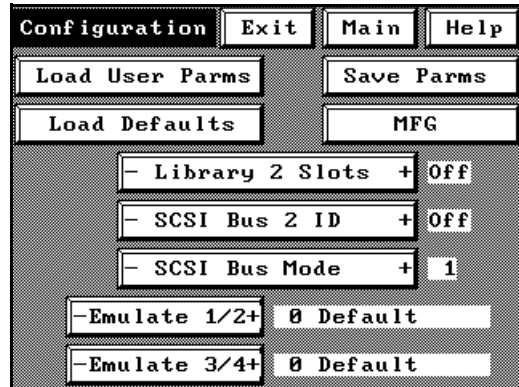
- Corrects front panel move problem.
- Removes load/unload retries and device resets (post drive error on front panel).
- Changes move to drive to wait 60 seconds for drive ready.
- Adds support for AIT-2 inquiry strings.
- Improves menu interface performance for fibre controller.
- Adds switch option 4 to set SDX-300C inquiry string (no switch update).
- Changes copyright to 1999.
- Changes SCSI_size to channel specific.
- Changes EXB-120 emulation to EXB-210.
- No longer hangs if SCSI bus not stable at power-up.
- Now must ship with SCSI bus mode set to 1 (as shown in Figure 1).

Figure 1 Drive switch configuration screen.

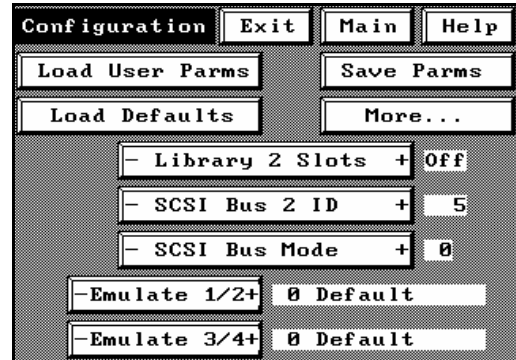
- Adds support for split logical libraries via second serial SCSI ports (the drive switch configuration screen selection has been separated for Drives 1/2 and 3/4), as shown in Figure 2.

Figure 2 Drive switch configuration screen.
